METLAKATLA PENINSULA LEAD-BASED PAINT INVESTIGATION

FOR THE
METLAKATLA INDIAN COMMUNITY
METLAKATLA, ALASKA

**Prepared by
Ridolfi Engineers Inc.
Seattle, Washington**

June 30, 1998

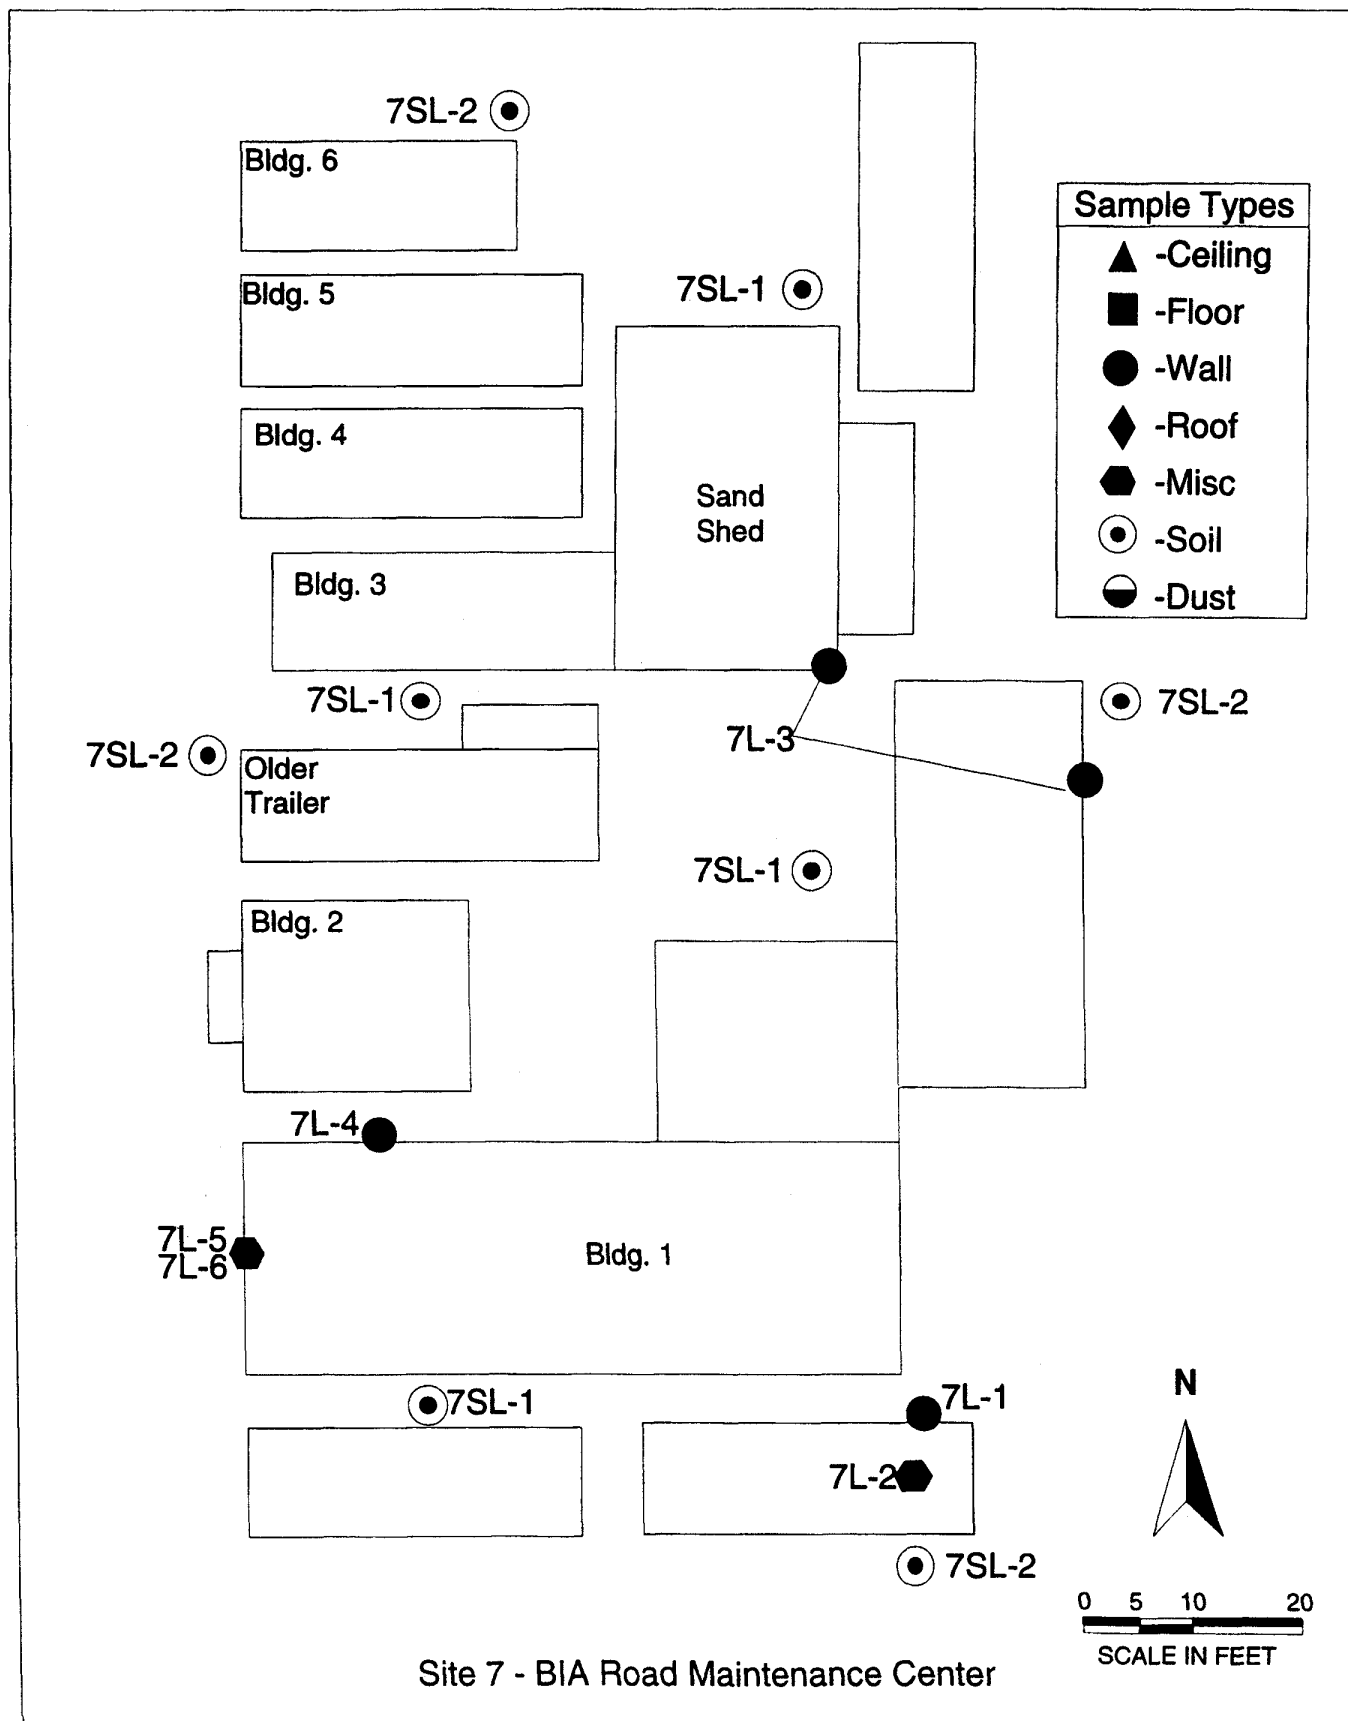
Six paint chip samples were collected of six different materials. Samples included exterior paints, trim paint, and bolt sealer. Two composite soil samples were also taken. Refer to the LBP Data Tables in Appendix B for descriptions of the material sampled and analytical information. See Figure 7-1 for sample locations.

Recommendations:
Wet scrape exteriors and encapsulate.

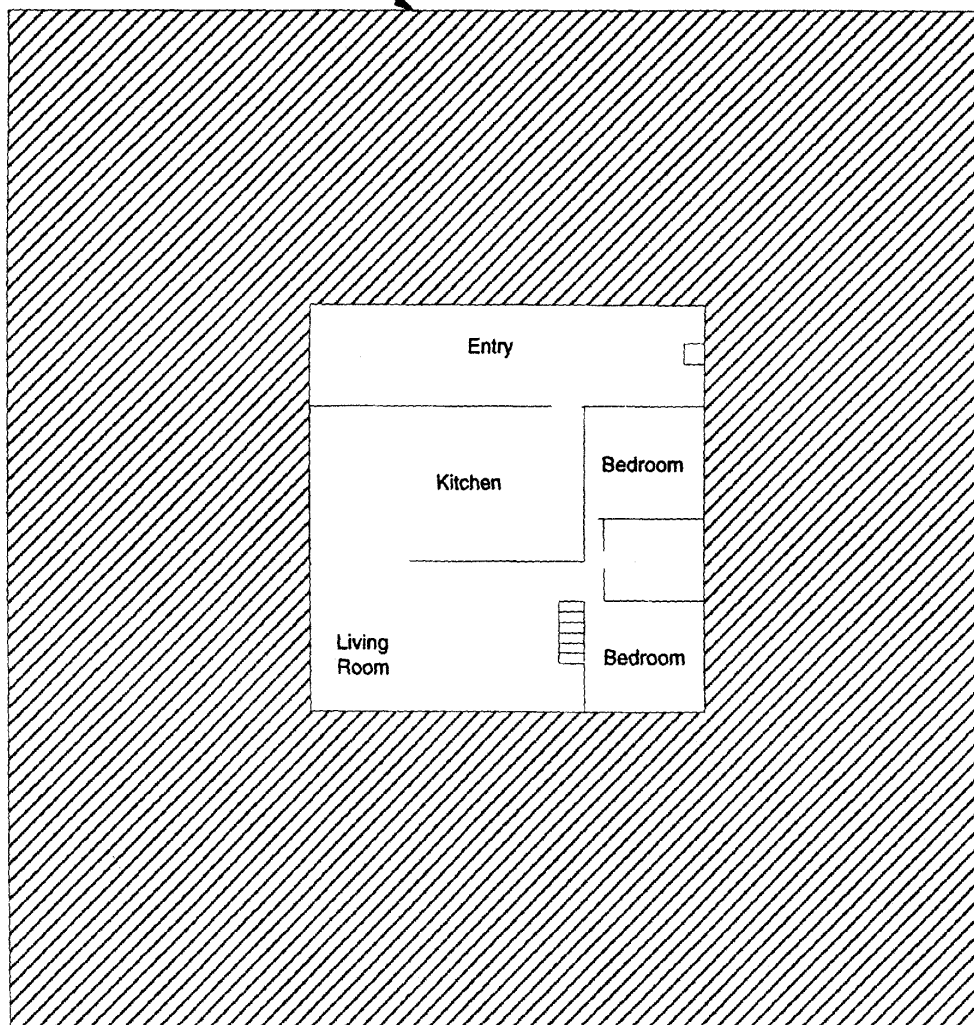
LBP Sample Locations

Limit of soil removal to a 1' depth

Recommendations:
Demolish condemned unit.
Remove soil to a depth of 1', 15' out from perimeter.
Replace excavated soil and hydroseed.

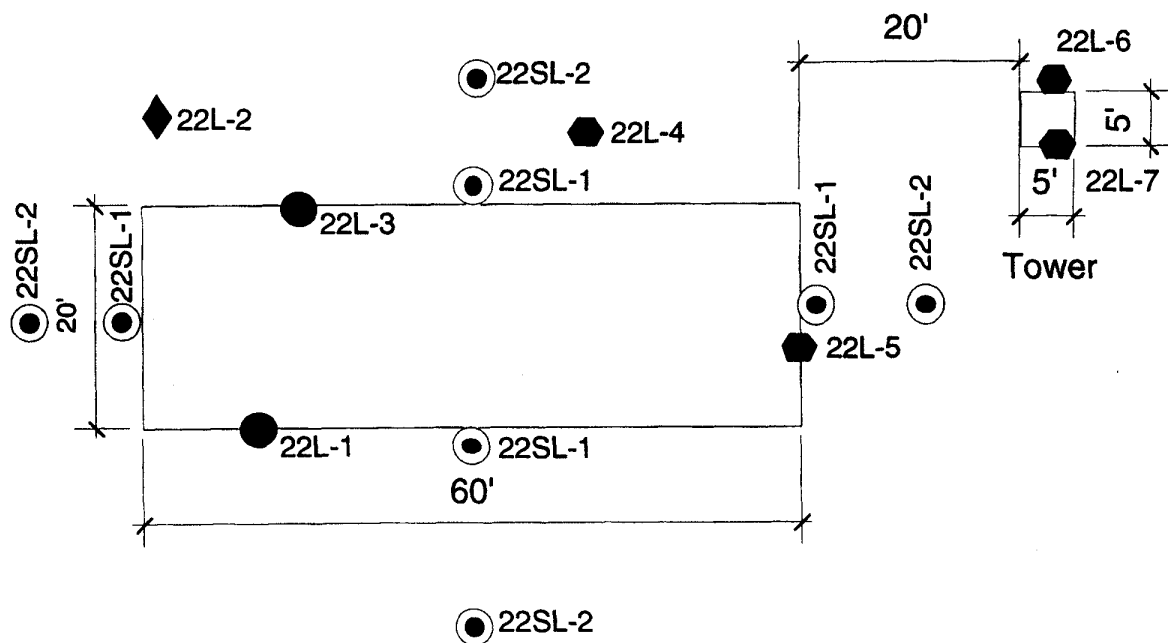
Site 22 DOD AACS Station

Composite soil sample
22SL-2 taken 15' from building.

Recommendations:
Remove and salvage tower.
Remove debris.
Remove soil to a depth of 1', 15' out from perimeter.
Remove soil under building area.

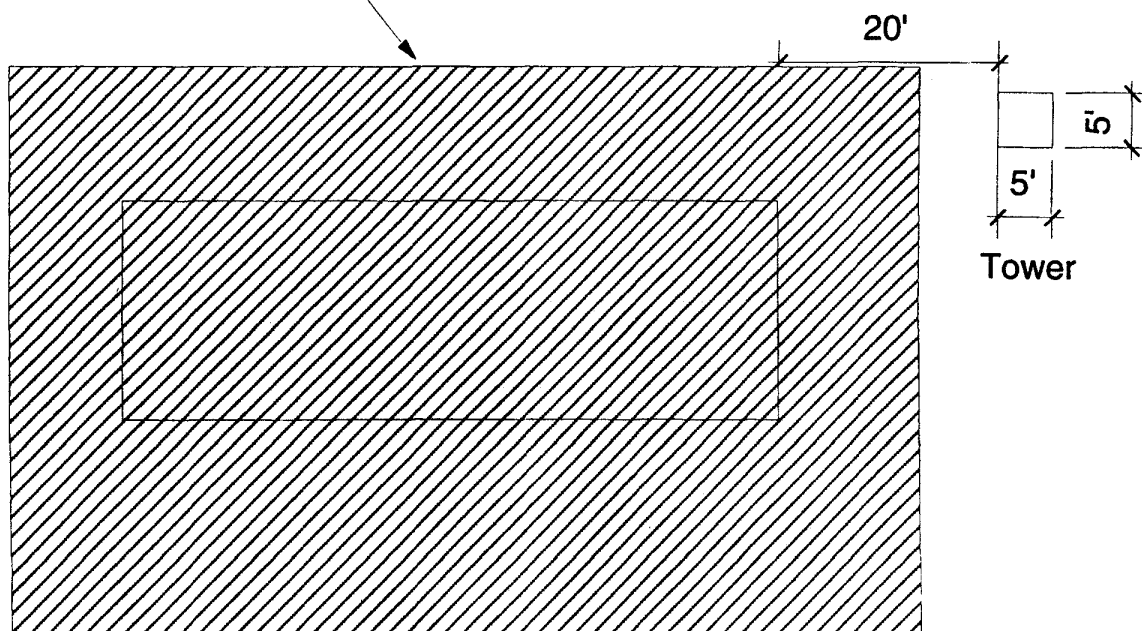
Limits of soil removal to 1'.

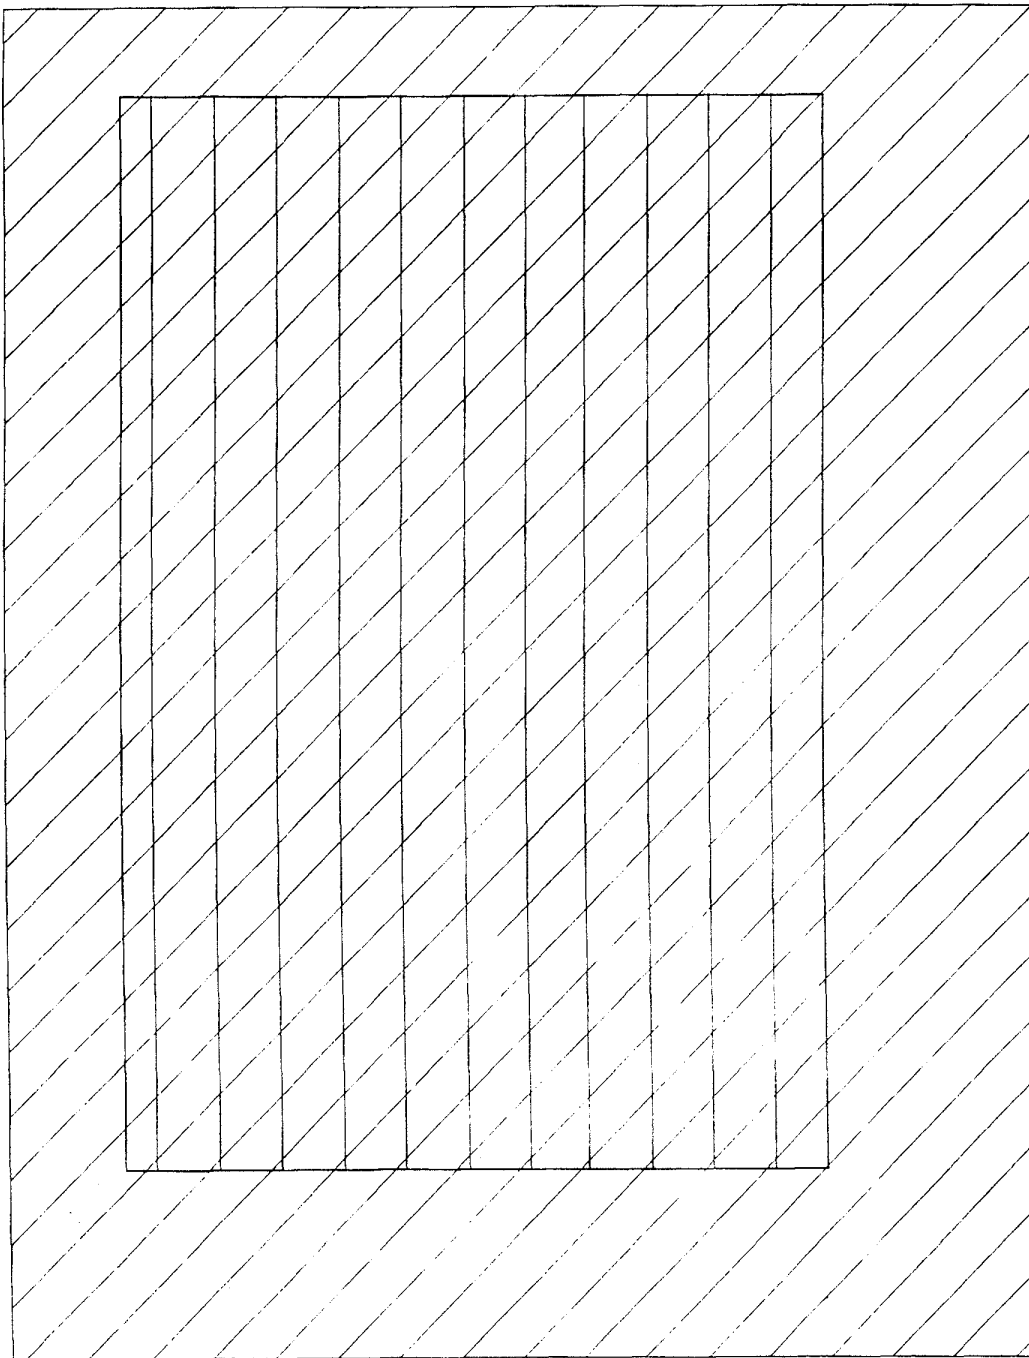
Figure 24-1

The remains of the middle marker facility consist of an 8-foot x 12-foot white wood-frame building (see photograph 24). The building is severely deteriorated and termite infested.

Recommendations:
 Demolish building.
 Remove soil to a depth of 1' to a distance
 of 15' from building, including under building.

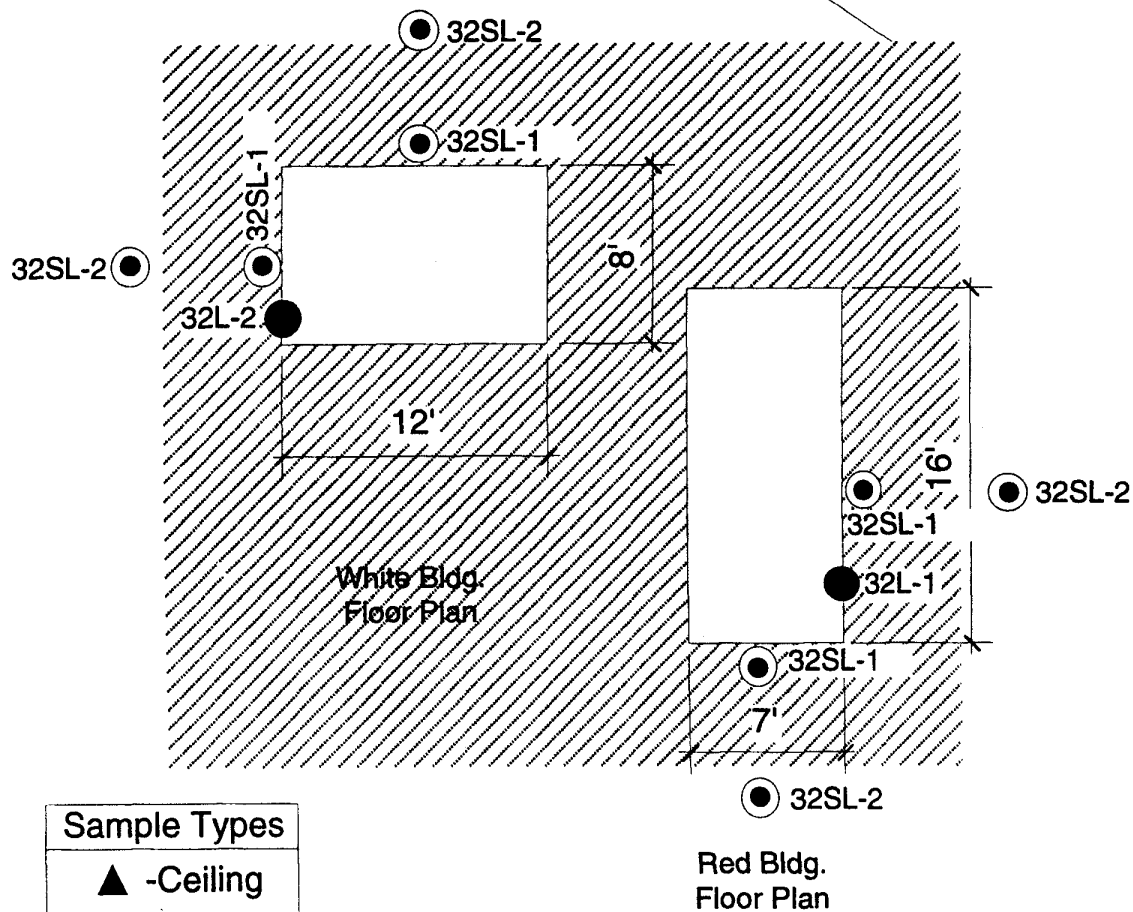
Limit of excavation for contaminated soil to 1' depth

Recommendations:
 Remove and salvage metal buildings.
 Excavate and remove lead-contaminated
 soil to a depth of 1' foot, to a distance of 15'.

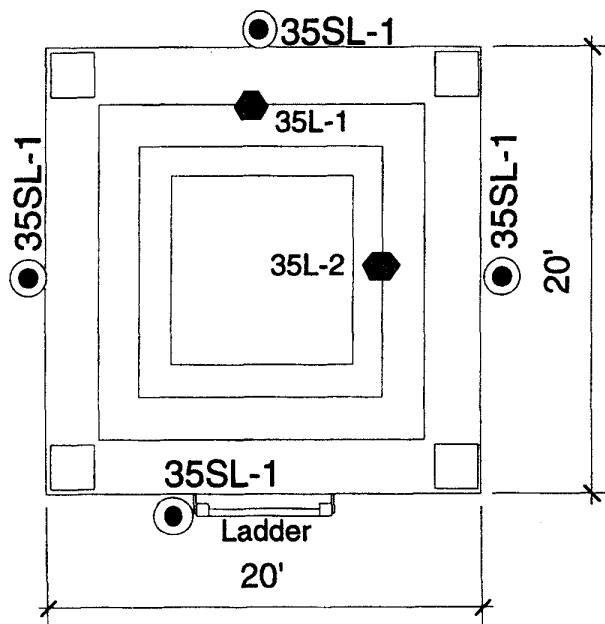
A small, approximately 15-foot-high faded red tower (see photograph 35) is located east of the main runway and south of the Runway to Camp Road.

Recommendations:
 Remove and salvage tower.
 Clean visible paint chips from ground surface.

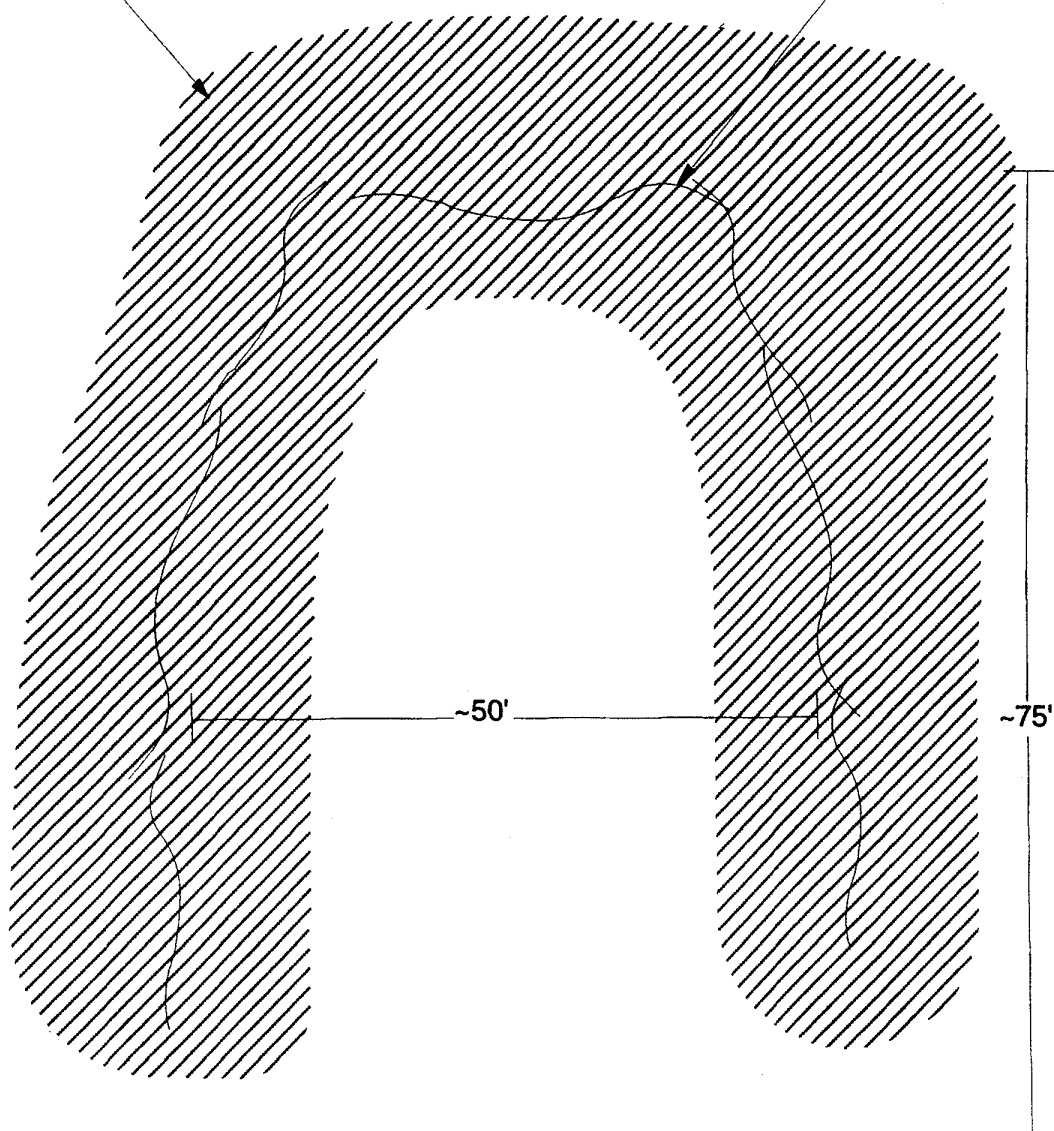
Limits of soil removal

Recommendations:
Remove and salvage metal.
Remove soil to depth of 1'.

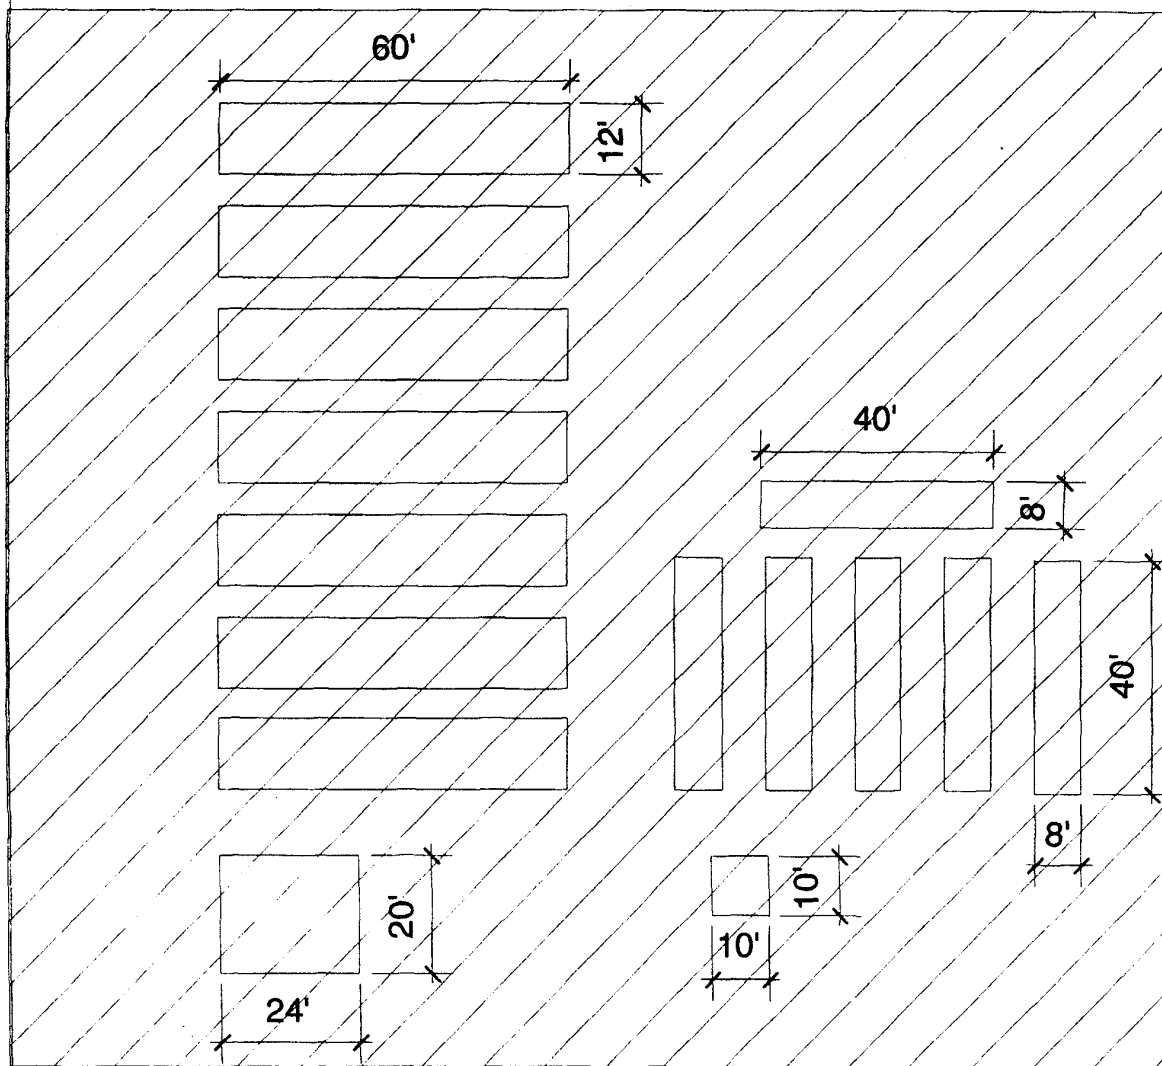
Seven paint chip samples were collected from the bulkload rack, building, tanks, valves, pipeline, and pumps. Two composite soil samples were collected at this site. Refer to the LBP Data Tables in Appendix B for descriptions of the material sampled and analytical information. See Figure 42-1 for sample locations.

Recommendations:
 Clean, cut up and salvage tanks.
 Remove 1' soil to a distance of 15' from tanks,
 including where tanks were previously located.

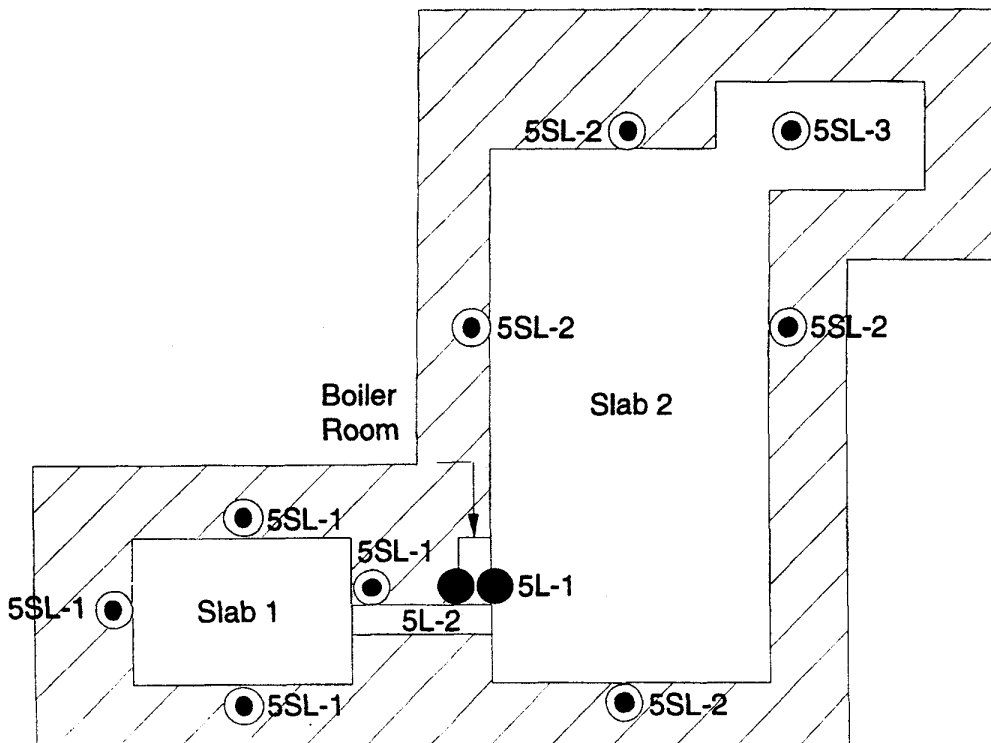
Photograph 54: Public School

The remains of the public school consist of a Z-shaped concrete foundation, a small concrete boiler room (see photograph 54), metal piping, metal structural steel, and metal building debris. The boiler room contains an insulated boiler and insulated piping. The debris contains vinyl floor tile, miscellaneous boiler debris, pipe insulation, and miscellaneous building debris.

Recommendations:
Remove soil to a depth of 1',
to a distance of 15' from slabs.

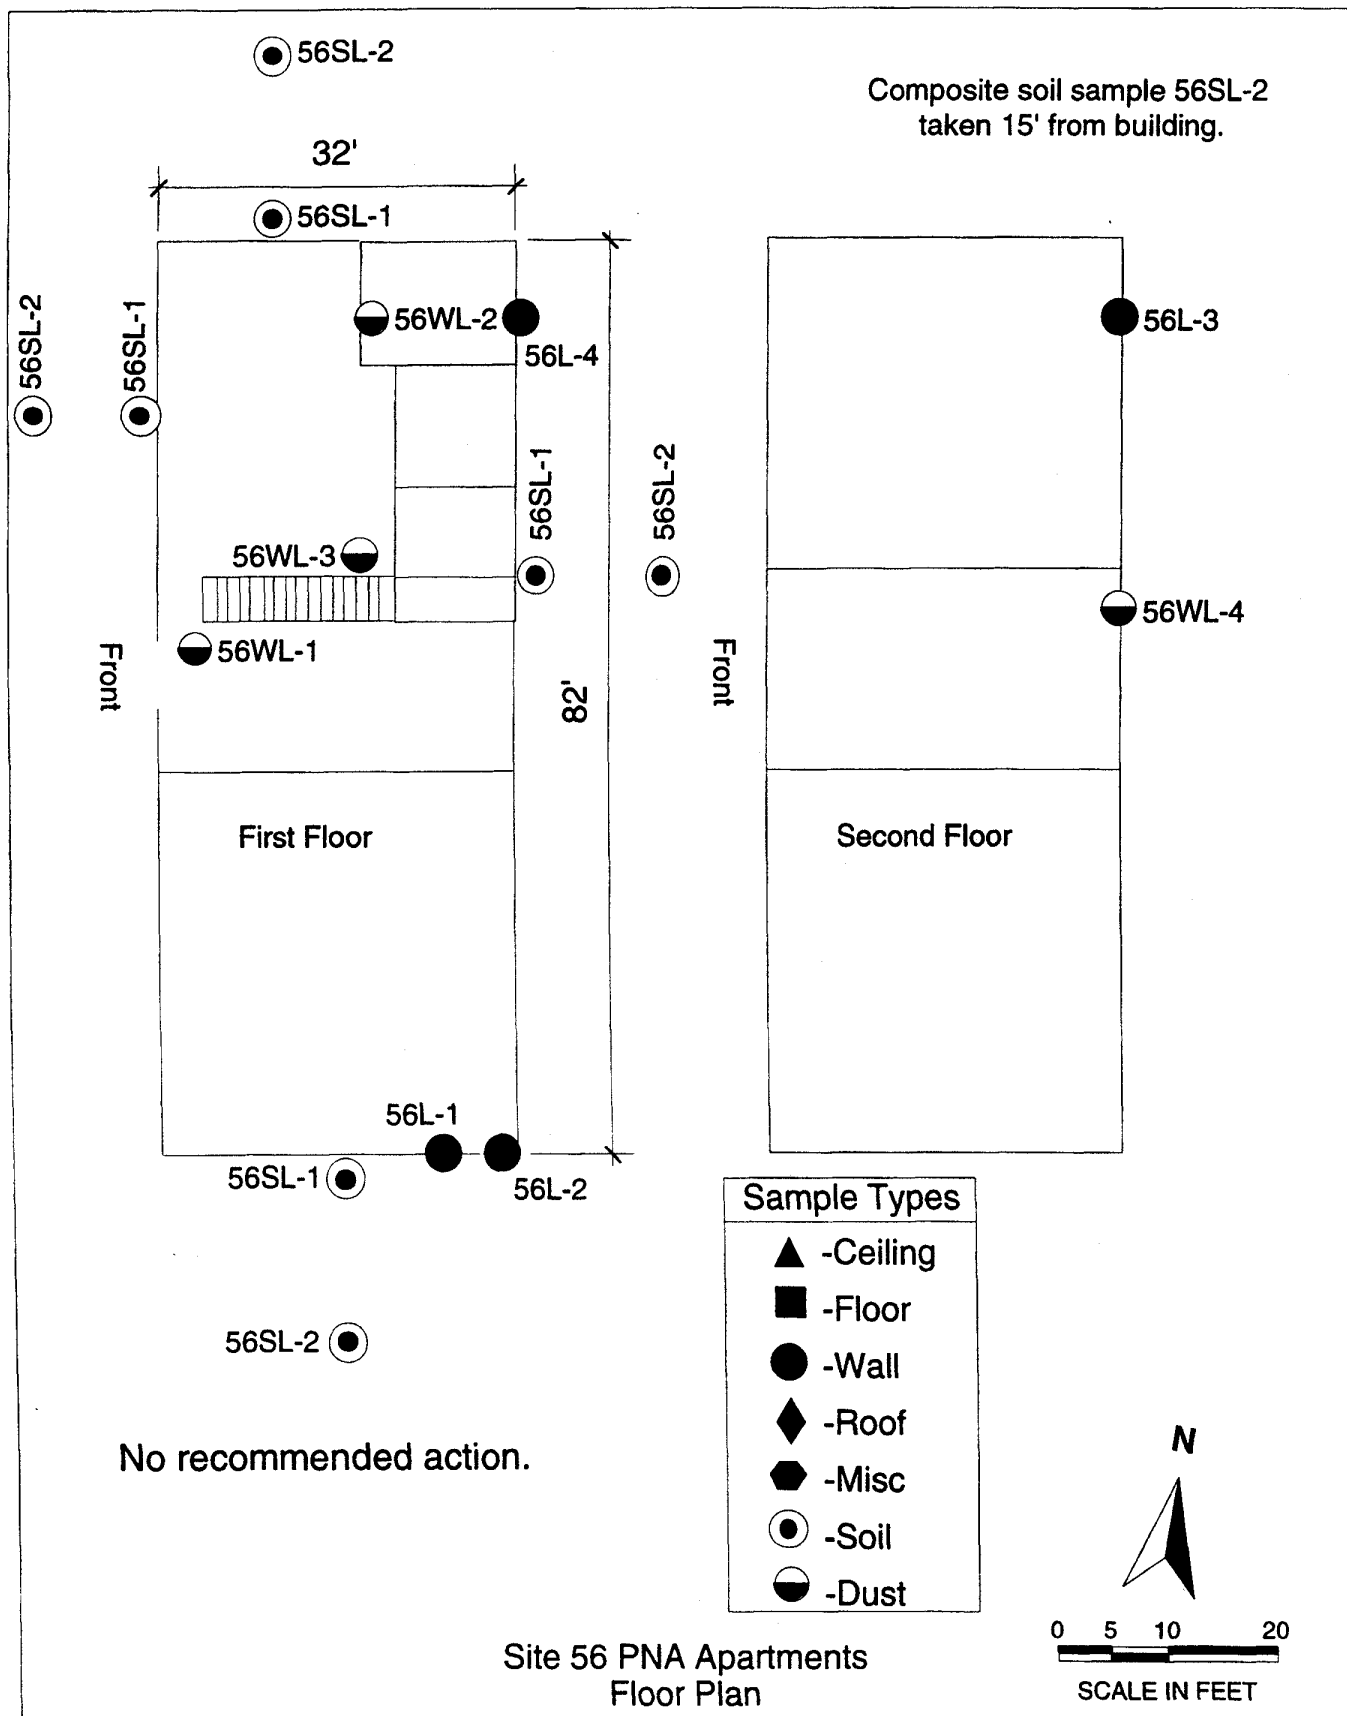
Photograph 56: PNA/WA Apartments

The approximately 35-foot x 85-foot structure (see photograph 56) was formerly an apartment building constructed for PNA/WA employees. It is currently occupied as residences by MIC members. The building is a two-story structure, with a wood and cementitious exterior skirting wall. The current residents have repainted the exterior and are remodeling and repairing the interior.

Building was repainted in the spring of 1997. Beige pink LBP and dark red lower-level LBP are no longer exposed. No action is recommended.

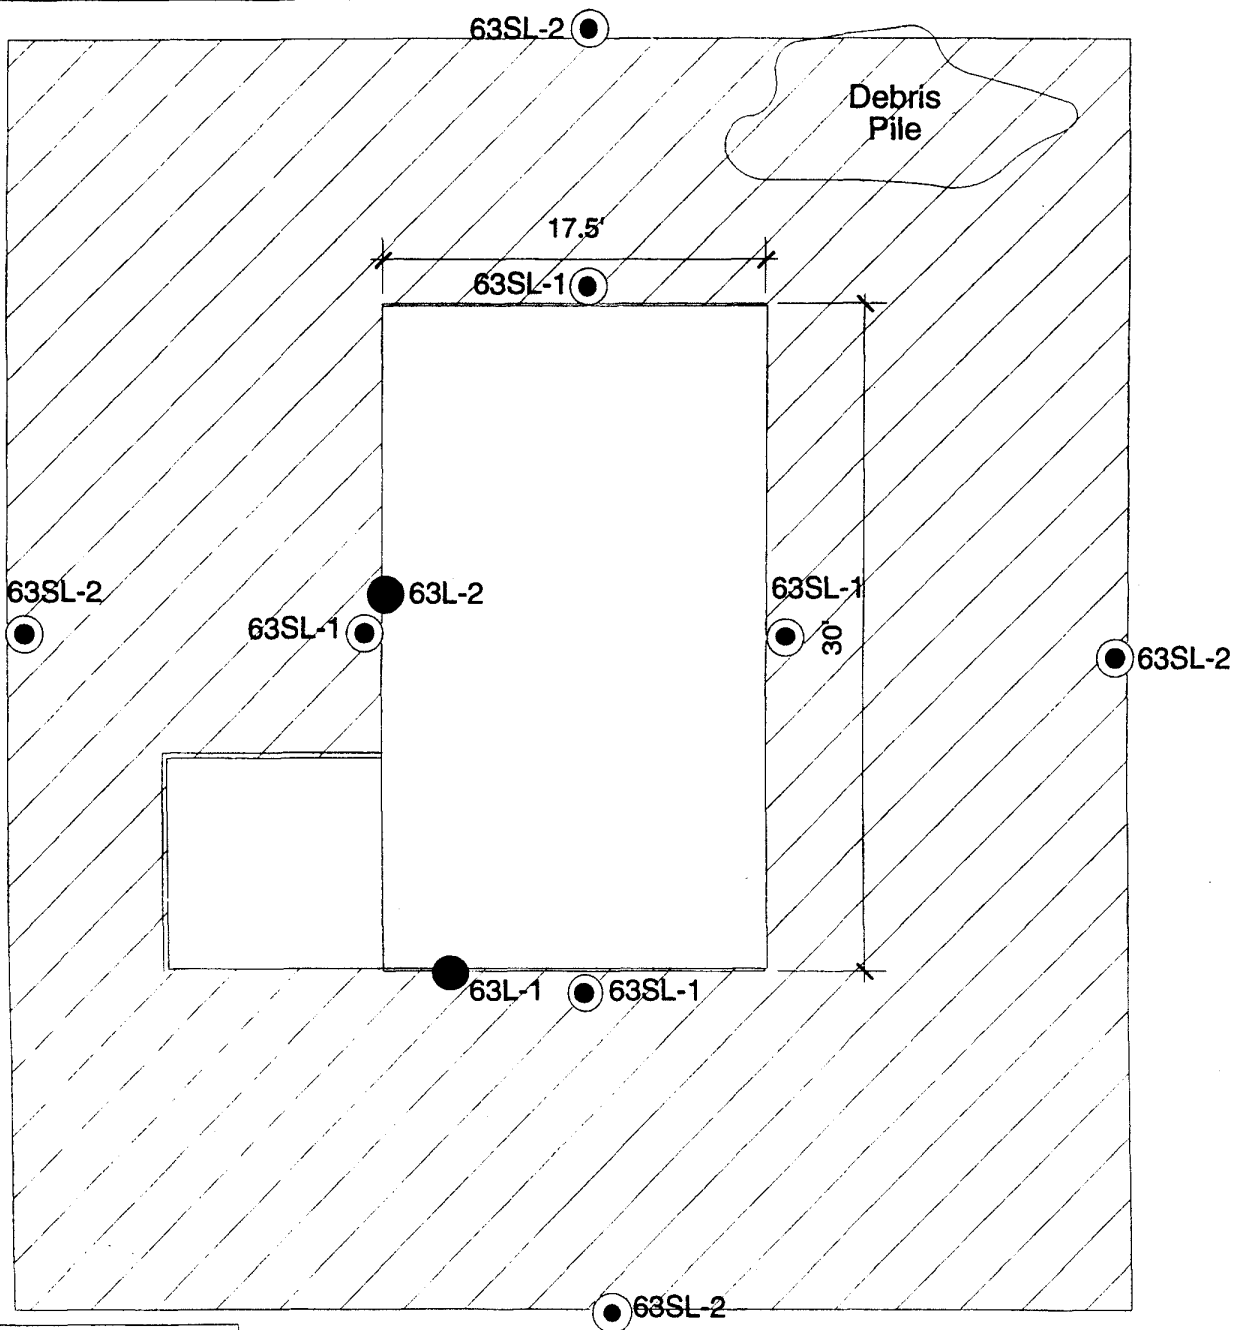
Photograph 63: Remote Receiver Station

The remains of the remote receiver station consist of a single-story, 20-foot x 30-foot concrete block building and a small, faded red-and-white 20-foot tower (see photograph 63). The remains of the small tower are located to the west of the building. The building contains abandoned electronic equipment and vinyl tile flooring. A toppled, faded red-and-white tower is located immediately north of the building. The station pad is bordered by ponded water. The perimeter embankments and nearshore pond areas are littered with what is apparently station-related debris (fuses, electrical conduit, a metal console, and building materials).

Recommendations:
 Remove towers.
 Remove soil to a depth of 1',
 to a distance of 15' from building

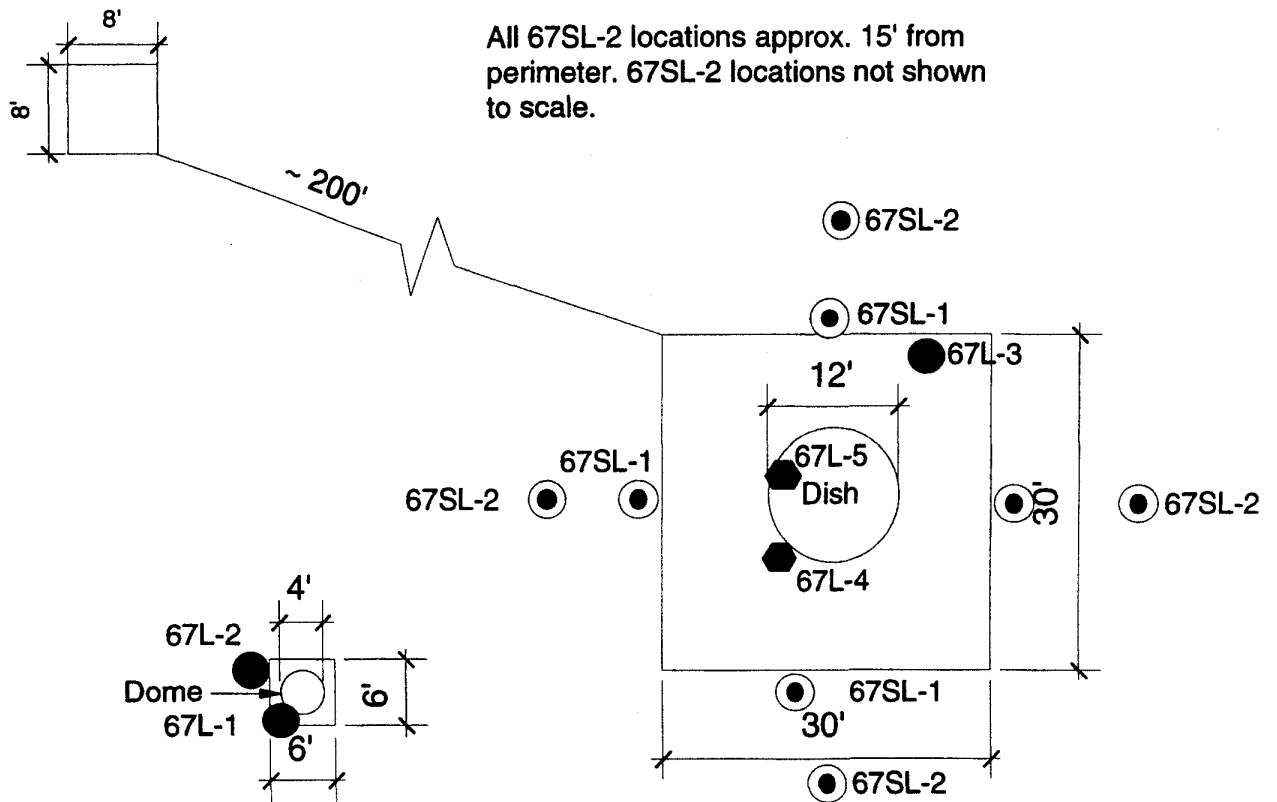
Photograph 67: Weather Bureau Station

The weather station contains two main structures: a 20-foot x 40-foot single story, wood-frame office building with an attached 20-foot x 20-foot storage building. A 20-foot x 30-foot, domed, wood-frame weather balloon release building and a smaller domed building (see photograph 67) are located on site, with other weather instrumentation nearby.

No LBP found.
No recommended action.

No action is recommended.

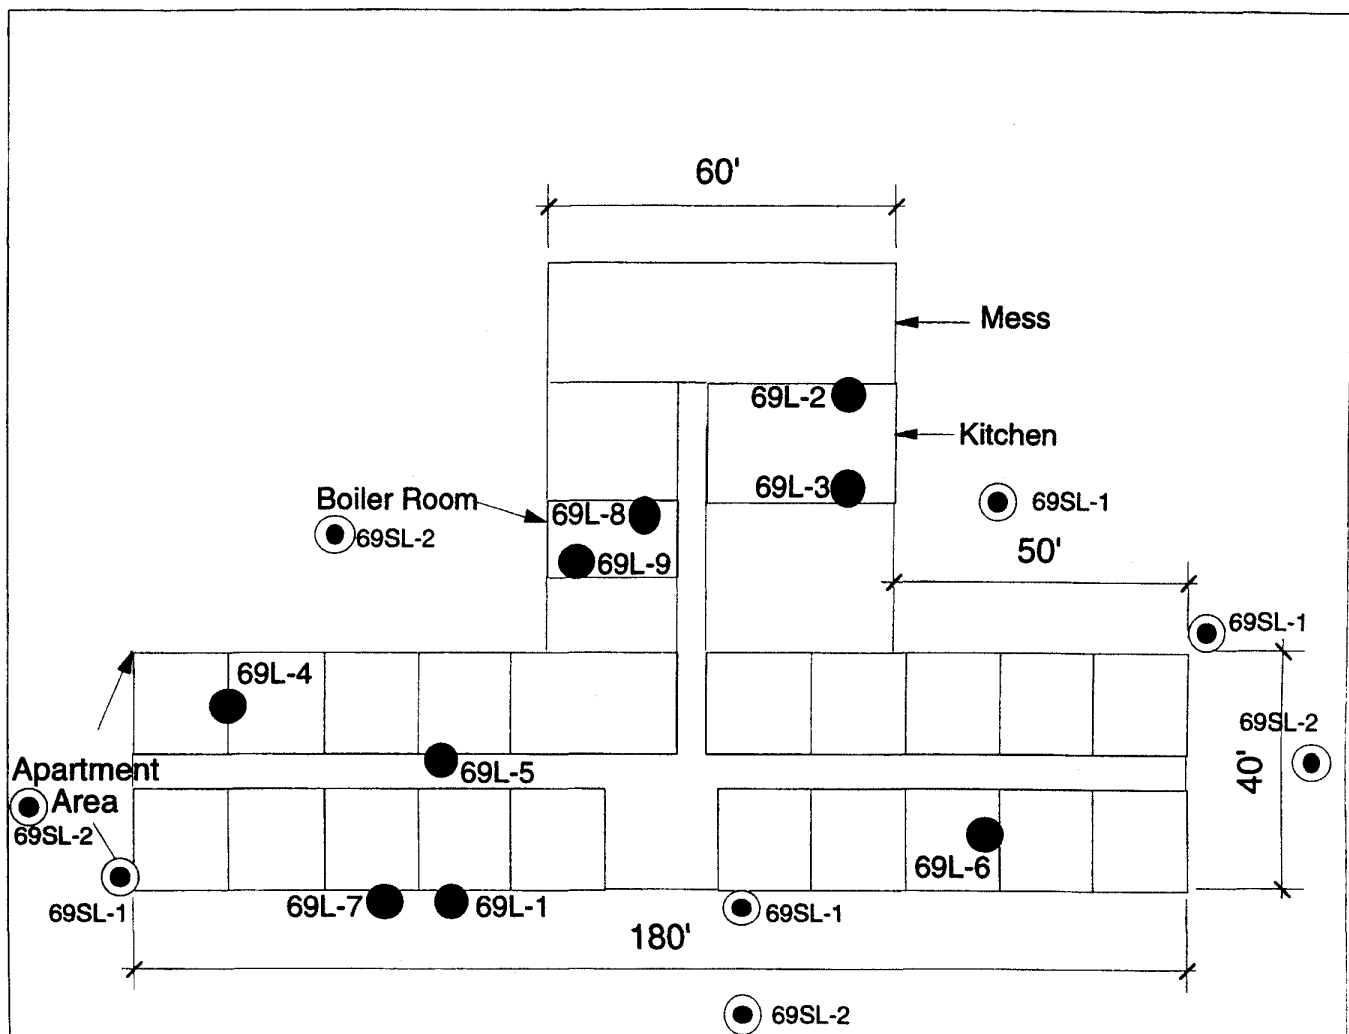
Photograph 69: USCG Quarters

The remains of the Coast Guard quarters consist of a two-story, T-shaped building that is divided into individual living units and shared lavatories. The building has a boiler room containing an insulated boiler, water tank and piping, vinyl tile flooring, and cementitious exterior siding. In 1997, a local entity started dismantling the structure (see photograph 69). The building is currently flagged as an Asbestos Hazard Area.

Recommendations:
Remove soil to a depth of 1',
to a distance of 15' from the
building perimeter.

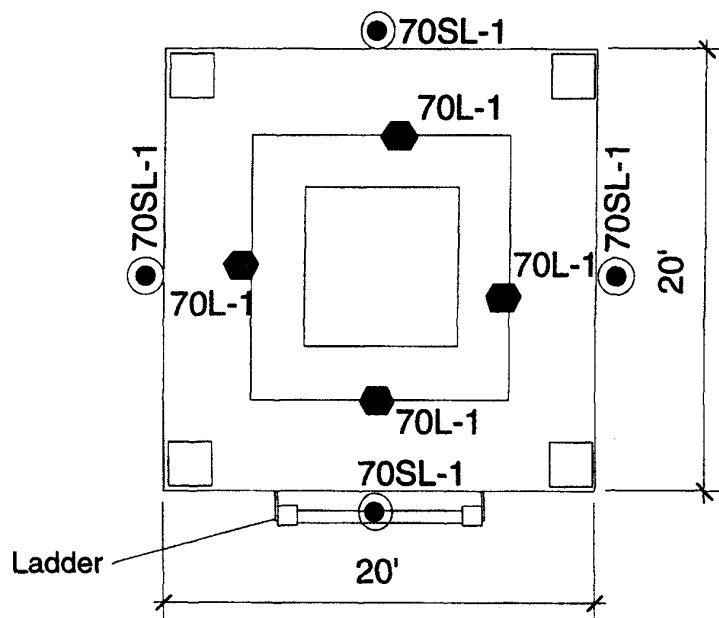
Photograph 70: Beacon Tower

The remainder of the DOD beacon is an approximately 70-foot, faded, red-and-white metal tower (see photograph 70).

Recommendations:
Remove Lead Based Paint and repaint tower.

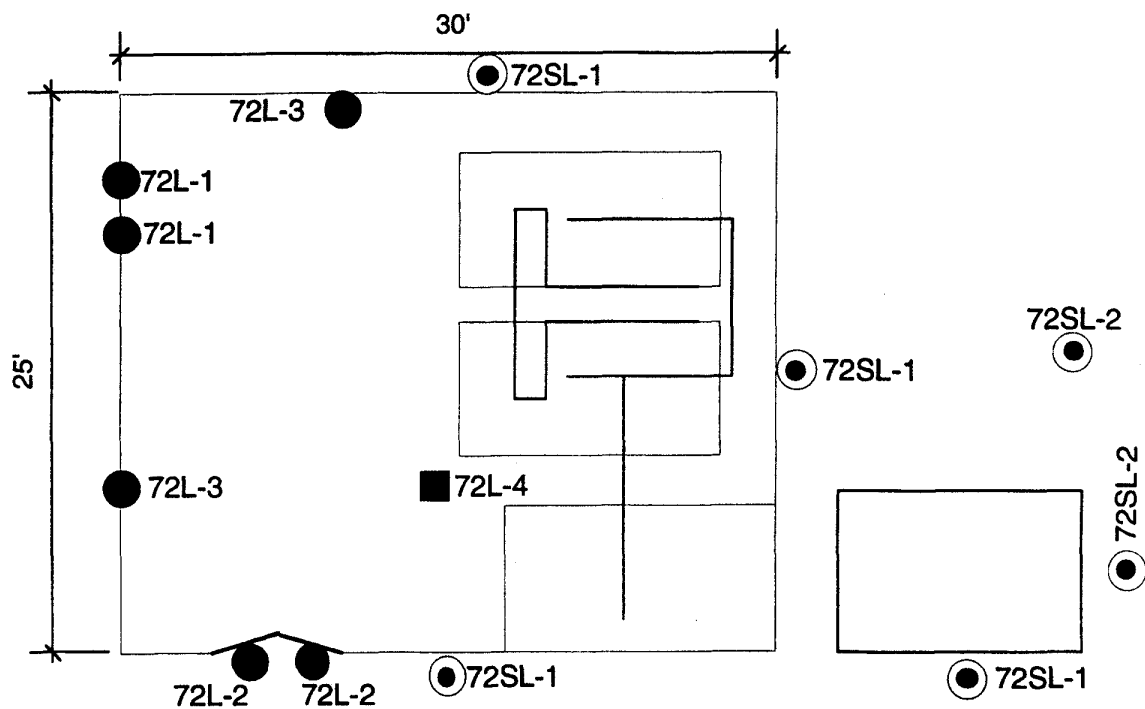
Photograph 72: Hangar Boiler Building

The boiler building (see photograph 72) is approximately 30-feet x 25-feet x 18-feet and contains two insulated boilers and associated insulated piping.

Composite soil sample 72SL-2
taken 15' from building.

Wet-scrape and encapsulate interior blue/gray wall surfaces. Remove and replace doors. Perform actions after asbestos abatement.

Recommendations:
Remove and replace doors.
Wet scrape and encapsulate
interior walls.

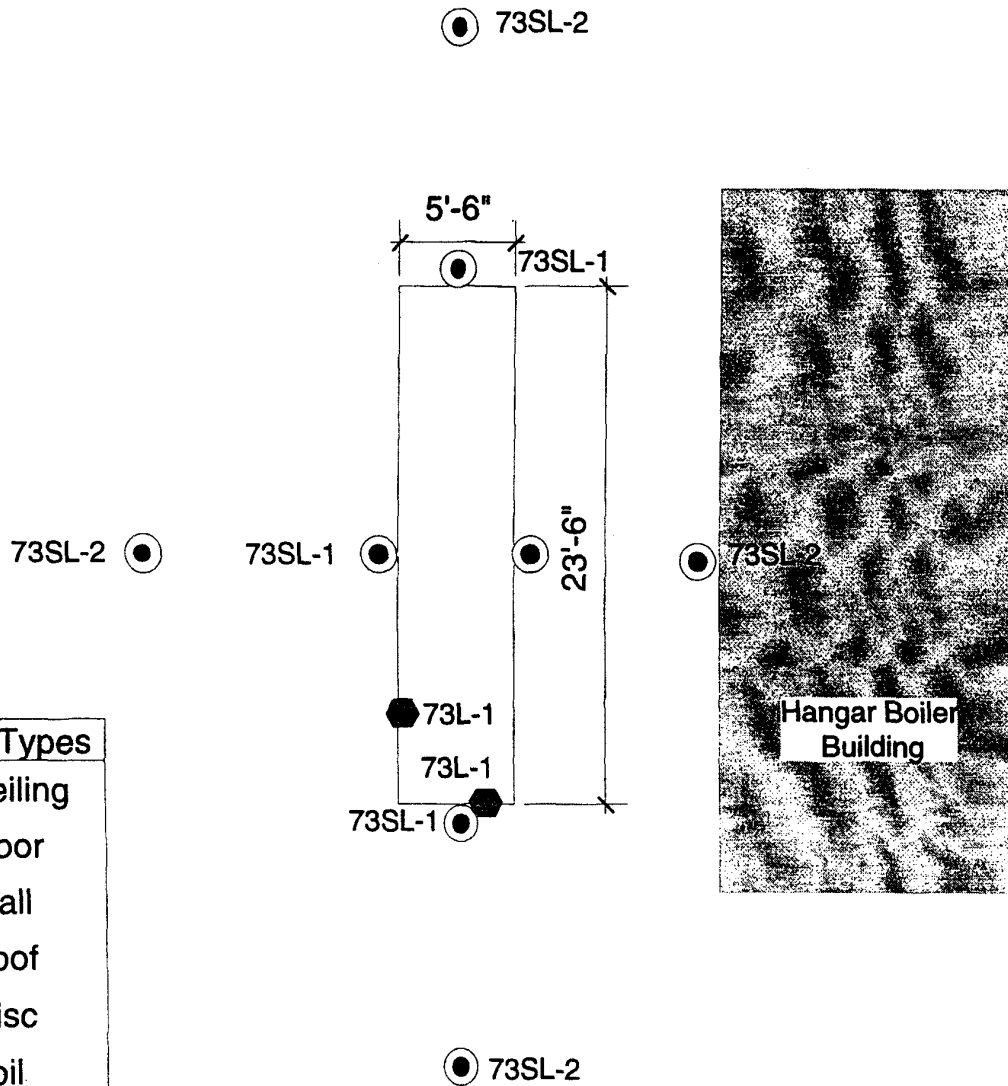
Photograph 73: Boiler Building AST

One 4,000-gallon AST is located south of the hangar boiler building (see photograph 73). The tank supplied fuel to the boilers in the adjacent building.

Recommendations:
Clean, dismantle and remove AST for salvage.
Excavate and remove lead-contaminated soil to
1' depth, to a distance of 15'.

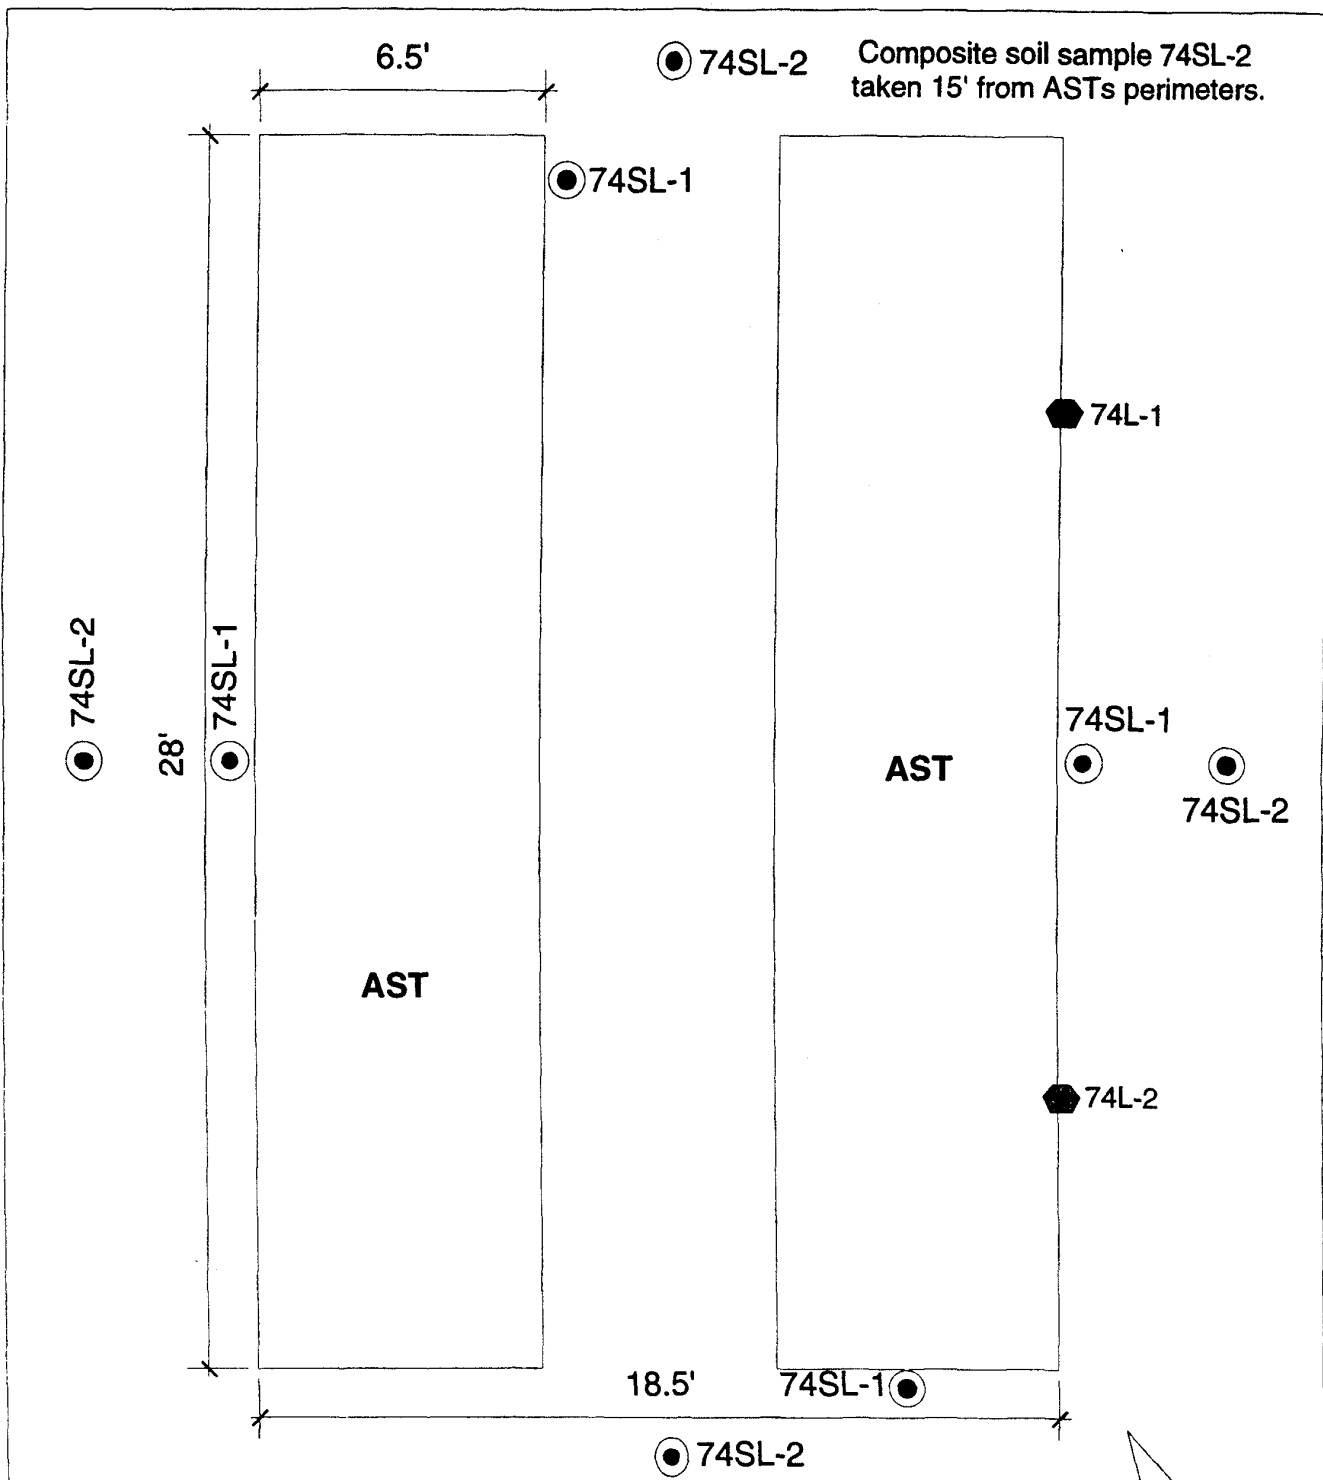
Photograph 74: USCG ASTs

The USCG ASTs are two 10,000-gallon tanks with a fuel loading swing nozzle positioned on elevated metal tank stands (see photograph 74). The ASTs stored fuel used in USCG flight operations.

Recommendations:
 Clean, dismantle and remove ASTs for salvage.
 Excavate and remove lead-contaminated soil to 1' foot depth, to a distance of 15'.
